WINDOWS FOR EXTERNAL OR INTERNAL HYDROSTATIC PRESSURE VESSELS

PART 11. Flat Acrylic Windows Under Short-Term

Pressure Application

Technical Report R-527

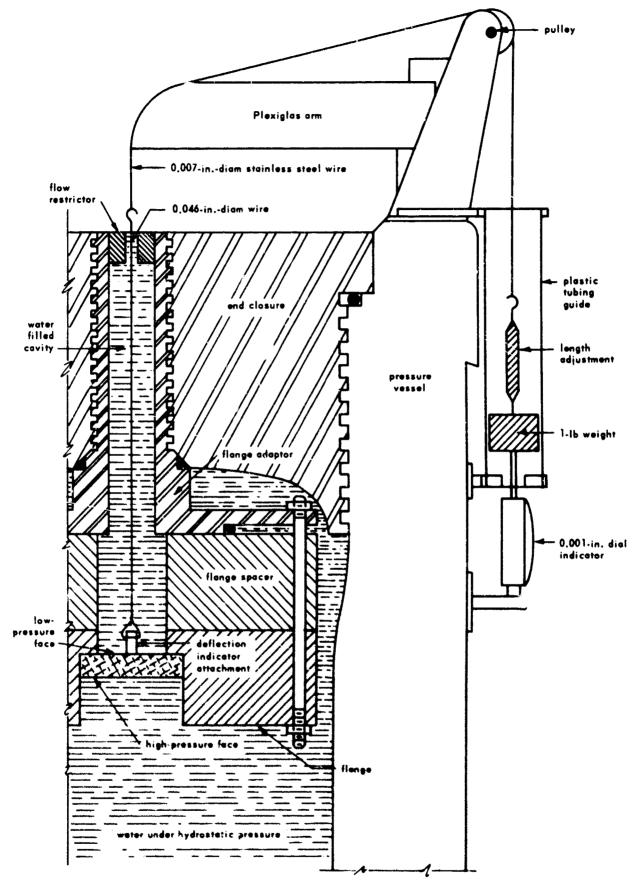
Figure 5. Schematic drawing of deflection measuring apparatus and flange mounting used in the testing of windows.

Figure 6. Ejection of window fragments by a high-pressure jet of water upon failure of the window.

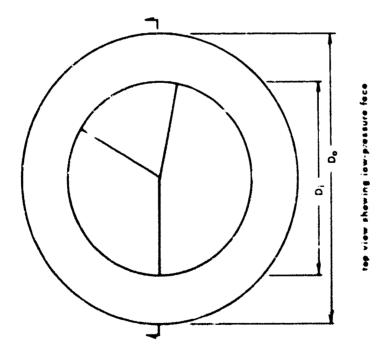
In nearly all cases for all sizes of windows tested, failure began with radial cracking on the window's low-pressure face. Radiating outward from near the center, the cracks commonly formed a nonsymmetrical, three- or four-pointed figure. This form of cracking preceded failure in nearly all cases and is assumed to be the beginning of failure (Figures B-1 and B-2). Depth of cracking was found to be a function of the thickness, t/D_i ratio of the window, and the pressure of the fluid. Since audible cracking was noted during testing, it is postulated that these radial cracks were rapidly formed, terminating at the window's D_i . Depth of cracking in the low-pressure face in most cases was found to be a small fraction of the window's thickness.

low-pressure face of windows. Figure B-1. Initial radial crack pattern in

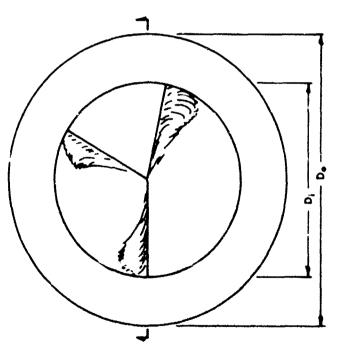
figure B-3. Second stage conchoidal fracture pattern, early development.

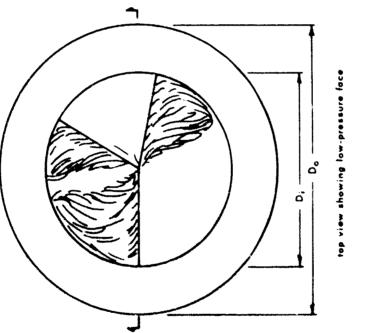
Figure B-5. Conchoidal fracture pattern, advanced stage of development.

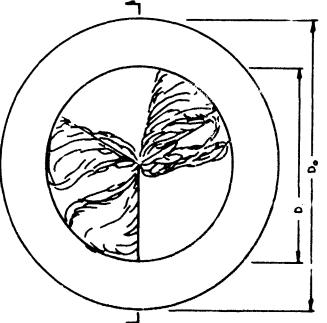
Figure B-8. Coalescing conchoidal fractures just prior to failure in a 0.735-inchthick window with a t/D; ratio of 0.490; maximum pressurization 18,600 psi.

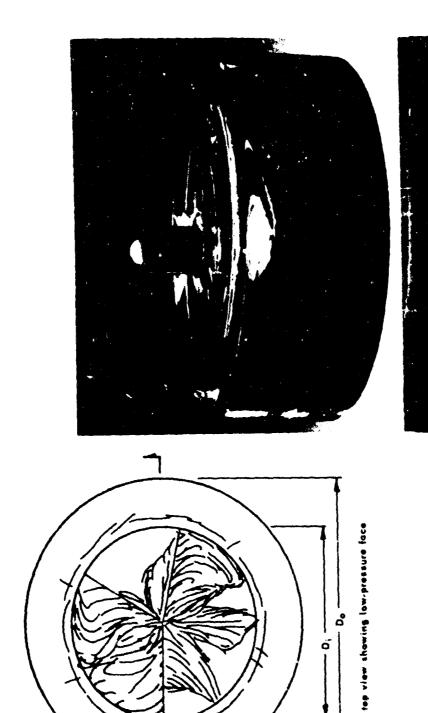
Figure B-7. Imminent coalescence of conchoidal fractures as critical pressure is approached.

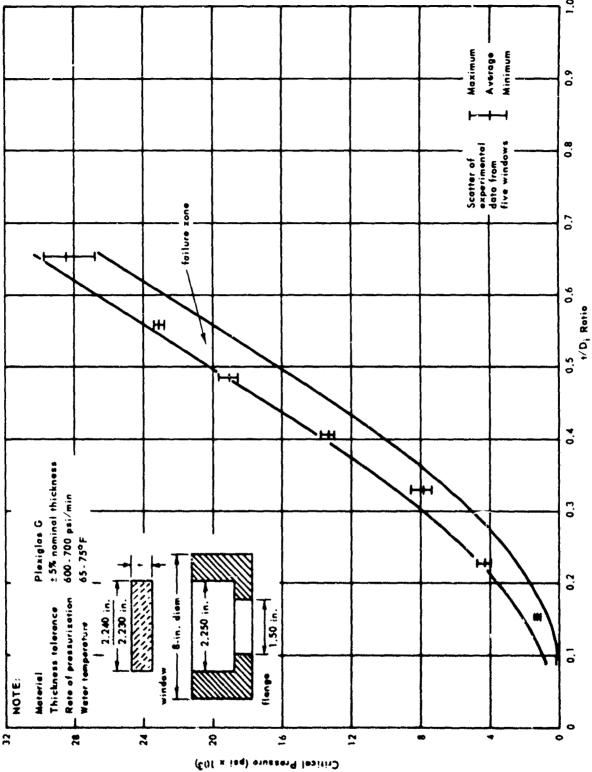
Figure 8-17. Relationship between critical pressure and $t/D_{\rm i}$ ratio of 1.50-inch (D;) flat acrylic windows.

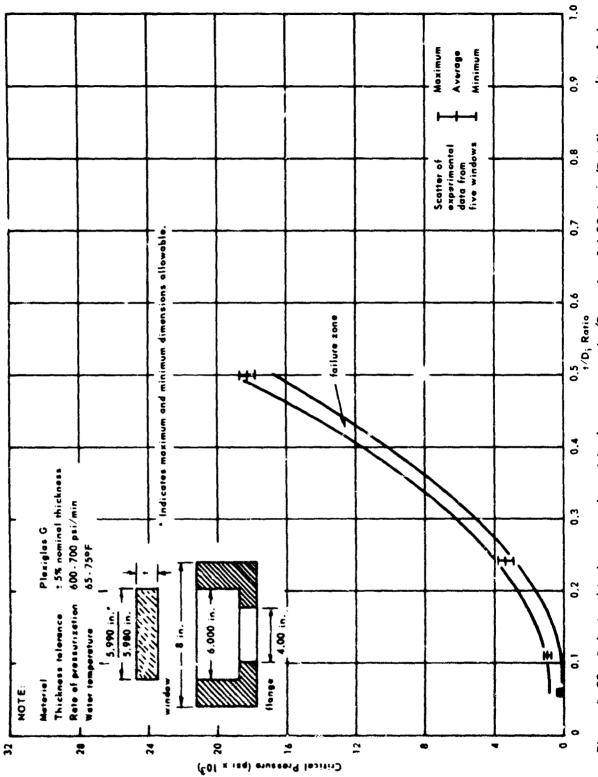
Figure 8-23. Relationship between the critical pressure and t/D_i ratio of 4.00-inch (D_i) flat acrylic windows.
